Manhole Inspection Summary

Manhole # S69A1_011MH

Insp Date: **2/21/08 10:25 AM**

Location Address: **2205 Van Deman St.**

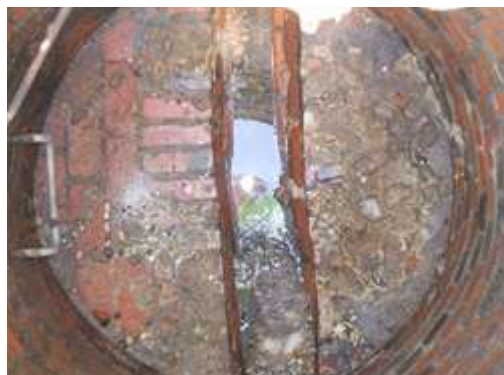
Top View

O12 at top of picture also faces North

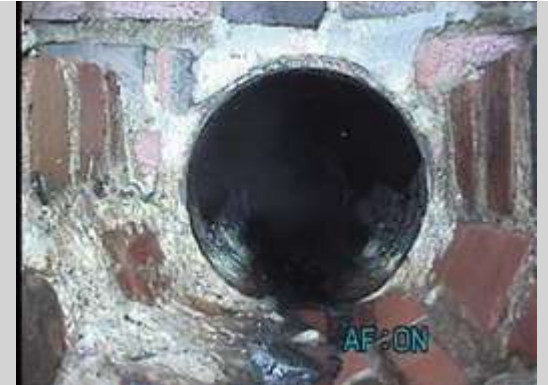
12 O'Clock Outflow

8 in. Circular Gravity Sewer
Pipe Out @ 12 O'Clock

Pipe Height: **8.4** (in.) Rod and Bar (Angled)
Pipe Material: **Clay** ☐ Pipe Lined
Invert Depth: **6.00** (ft.) Flow Characteristics: **Slow**
Deposits: ☒ None ☐ Mud ☐ Sludge ☐ Debris ☐ Grease
Silt Depth: (in.) Deposits Extent:
Infiltration: **None** Pipe Seal Cond: **Sound**

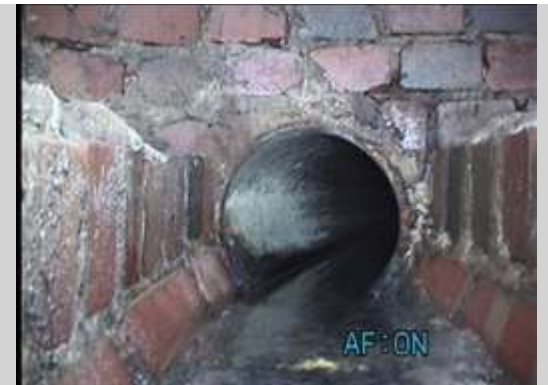
6 O'Clock Inflow

8 in. Circular Gravity Sewer
Pipe In @ 6 O'Clock

Pipe Height: **8.4** (in.) Rod and Bar (Angled)
Pipe Material: **Clay** ☐ Pipe Lined
Invert Depth: **5.83** (ft.) Flow Characteristics: **Slow**
Deposits: ☒ None ☐ Mud ☐ Sludge ☐ Debris ☐ Grease
Silt Depth: (in.) Deposits Extent:
Infiltration: **None** Pipe Seal Cond: **Sound**
